COMPROVANTE LAVORO N° / Work Report N°M057A13		DATA / Date 08/02/2017
CLIENTE / Customer MSC	NAVE/IMPIANTO/ Vessel/ Plant M/N MSC-ANGELA	MACCHINARI/ Equipment Winch Hydraulic System
LOCALITA'/ Town	Antwerpen	
OPERATORE/Service Engineer	Di Giosia G., Manzoni D.,	
LAVORO EFFETTUATO E MATERIALE SOSTITUITO / Job carried out and spares renewed (1/1)

Service on board during dry Dock in antwerp.
Details of the activities carried.

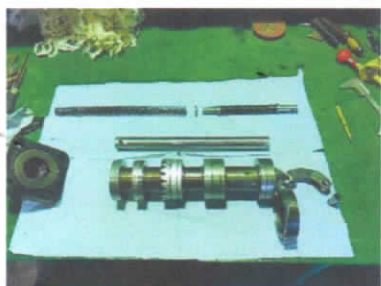
- Mooring Winch middle.

Found oil leaks from handle shaft of maneuvering valve. Complete dismantling of all components of the distributor and check. Cleaning of sealing seats, renewal seal kit and assembly.

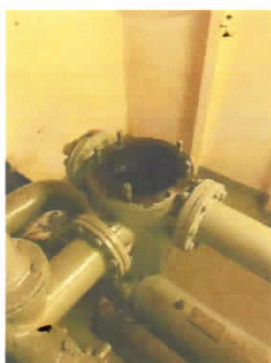
- Pump room.

Found oil leaks on pressure line of stbd side main pump. Dismantling, cleaning of the sealing seats, renewal seal kit and assembly.

Removal and check of the two return line filters. Not found steel debris.

Replace of hydraulic oil (delivery by crew).

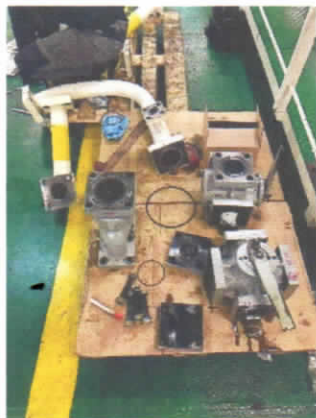
- Pump room.

Found oil leaks on all pressure lines of the two main pumps. Dismantling, cleaning of the sealing seats, renewal seal kit and assembly.

Removal and check of the two return line filters. Not found steel debris.

Removal, cleaning and replacement seal kit of the cover of pressurized expansion tank.

Replace of hydraulic oil (delivery by crew).
